Aviation Investigation Preliminary Report

Location:	Kearney, MO	Accident Number:	CEN23FA314
Date & Time:	July 20, 2023, 09:34 Local	Registration:	N200RA
Aircraft:	Piper PA-31P	Injuries:	1 Fatal
Flight Conducted Under:	Part 91: General aviation - Ferry

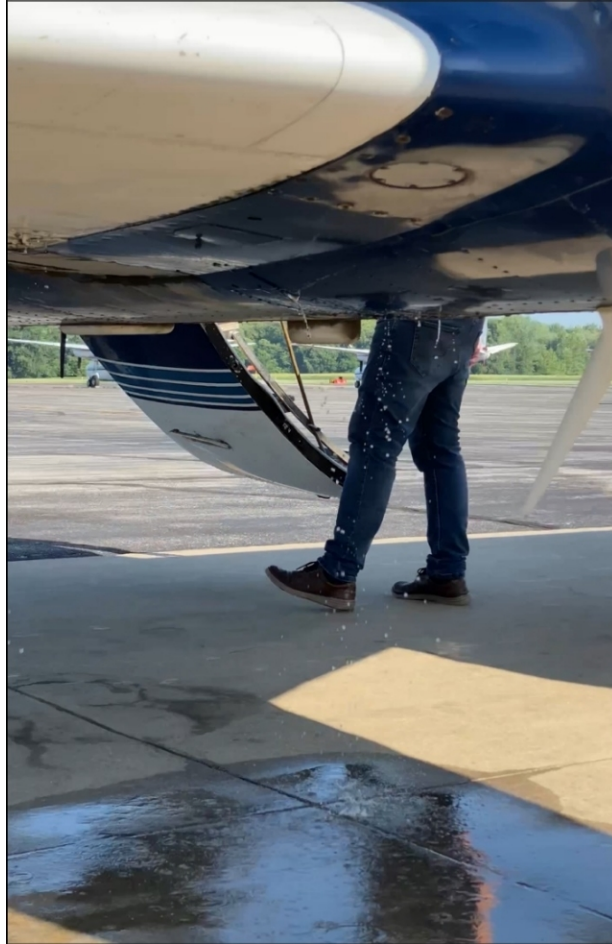
According to multiple witnesses, the owner and a mechanic worked on the airplane for about six months; the most recent annual inspection was completed in 2015. Two witnesses reported that during an engine ground run about two weeks before the accident, the right engine was difficult to start and would not produce full power. The witnesses also stated that the inboard fuel tanks “horribly” leaked fuel anytime the airplane was fueled.

Before the accident flight, the owner requested an airport lineman to fuel the airplane. During the fueling of 18.53 gallons of Avgas, an unknown amount of fuel leaked from the right-wing inboard fuel tank (see Figure 1.). According to the mechanic, the airplane had 140 gallons onboard divided between both 50 gallon inboard wing fuel tanks and 40 gallons in the right wing auxiliary fuel tank.

Figure 1: Video screen capture of the fuel leak provide by the lineman witness.

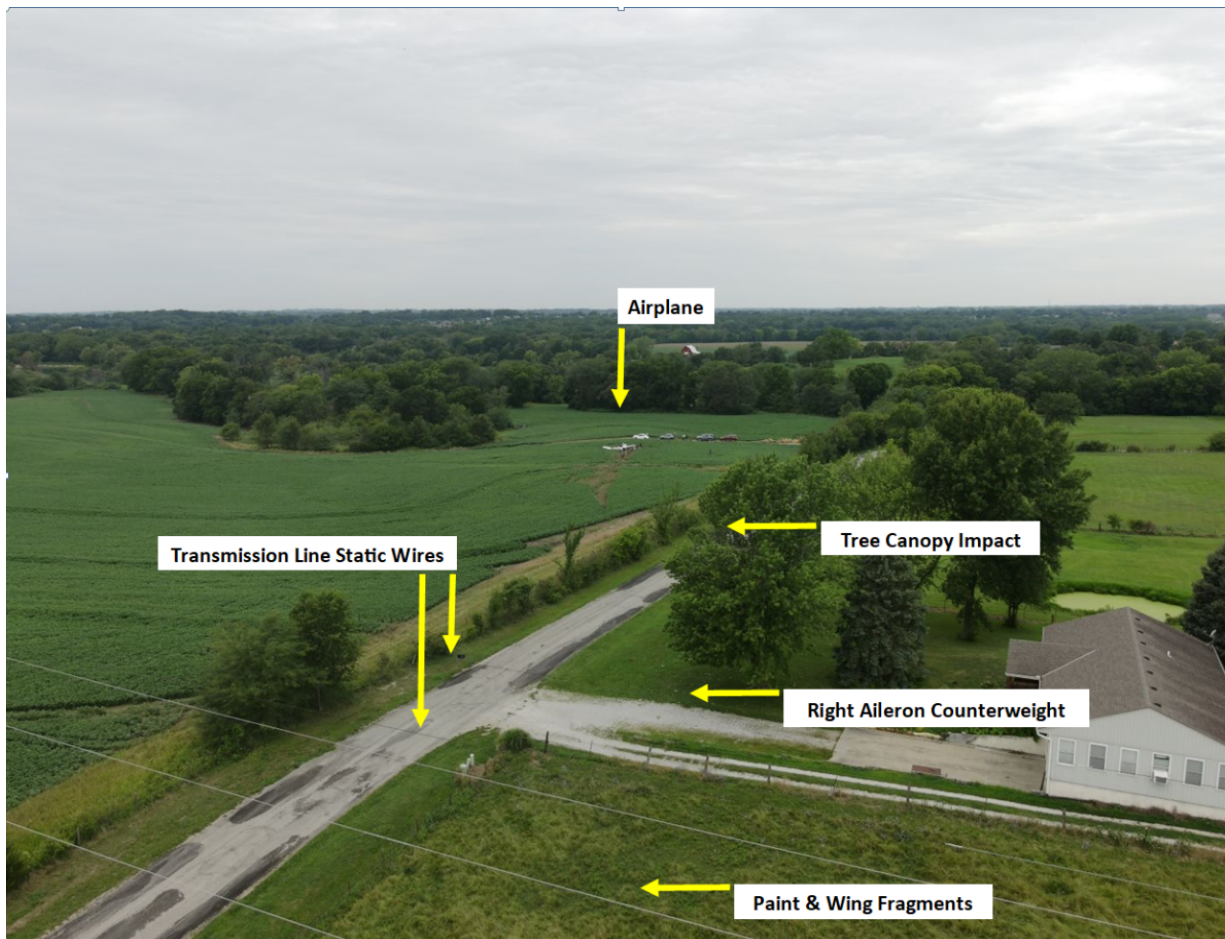
A witness about 1.60 nautical miles to the north of the airport stated he heard a loud airplane which appeared from behind trees headed towards his residence. He observed the airplane strike two static wires on a power transmission line before it impacted the canopy of a large tree in his front yard (see Figure 2.). The airplane continued in a left bank toward a nearby soybean field and impacted the terrain in a nose-low, left bank attitude. The airplane slid several hundred feet, and a postcrash fire ensued.

Figure 2. Transmission line and tree impact provided by the IIC

The accident site was located in a relatively flat agricultural field about 1.6 nautical miles north of the runway. The wires were located about 735 ft before the main wreckage and were about 65 ft above ground level (agl). The second identified point of contact was tree canopy impact about 60 ft AGL and 150 ft after the wire strike. The airplane then impacted the ground and a debris path extended in the field about 313 ft. on a heading of 254°, to the main wreckage.
