Aviation Investigation Preliminary Report

Location:	Kearney, MO	Accident Number:	CEN25FA346
Date & Time:	August 27, 2025, 11:58 Local	Registration:	N888MT
Aircraft:	Cessna 340	Injuries:	2 Fatal
Flight Conducted Under:	Part 91: General aviation - Personal

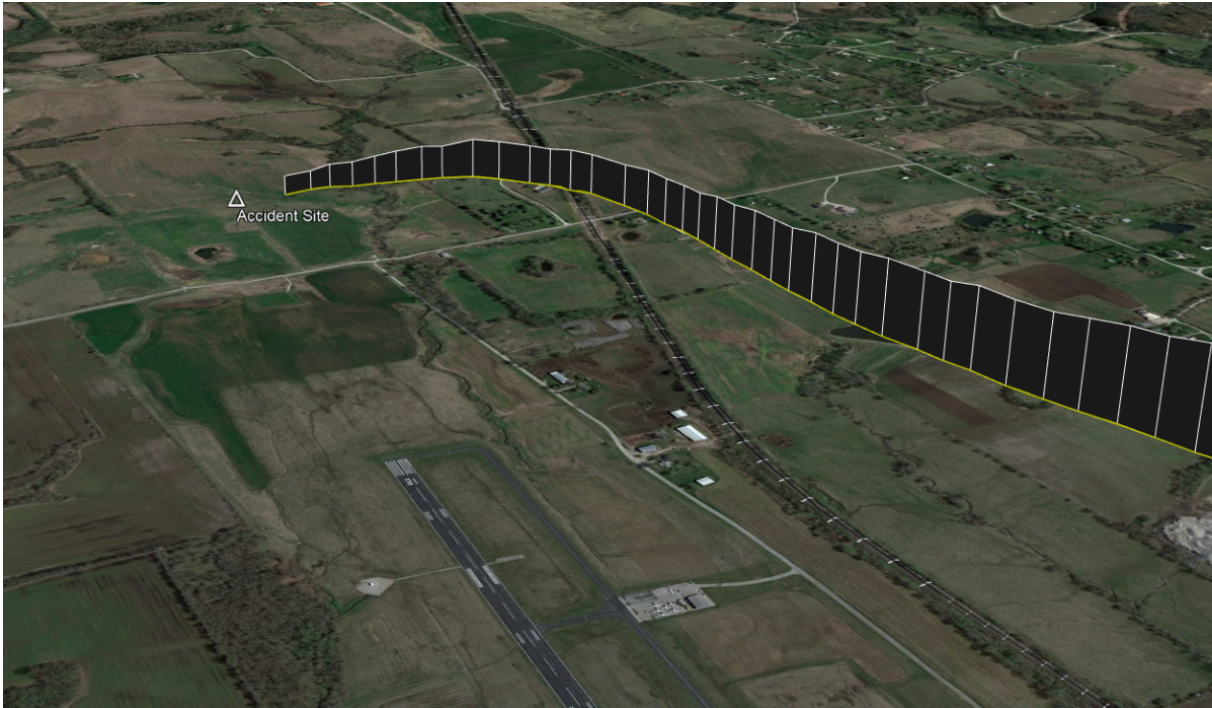
Figure 1 ADS-B and Accident Site

ADS-B data showed that the airplane departed the Washington Regional Airport (KFYG), Washington, Missouri, about 1057, and cruised at 4,500 ft mean sea level towards the Midwest National Air Center Airport (KGPH), Mosby, Missouri. About 25 miles from the airport, the airplane descended and entered the traffic pattern for a left base turn. The airplane's altitude was lower than normal for a standard traffic pattern and continued to descend.

An eyewitness who lived near the accident site reported that the airplane appeared to be low and slow. The airplane's left wing dipped down momentarily, returned wings level, then the left wing dipped again, and the airplane rolled left until it collided with terrain.

The airplane impacted an uncultivated soybean field about 0.6 miles from the approach end of runway 18. The initial impact point consisted of ground scars consistent with the left wing and airplane nose. A divot in the ground made by the right engine contained the right propeller assembly which had fractured at the crankshaft. The debris field was about 95 ft long, orientated along a 225° magnetic heading. The main wreckage consisted of the remainder of the airplane, to include the fuselage, empennage, tail section, both wings, both engines, and the left propeller. The main wreckage was aligned on a 120° magnetic heading. A postimpact fire had consumed a large portion of the fuselage.
