Aviation Investigation Preliminary Report

Location:	Butler, MO	Accident Number:	CEN26FA224
Date & Time:	June 14, 2026, 11:25 Local	Registration:	N221BN
Aircraft:	PACIFIC AEROSPACE LTD 750XL	Injuries:	12 Fatal
Flight Conducted Under:	Part 91: General aviation - Skydiving

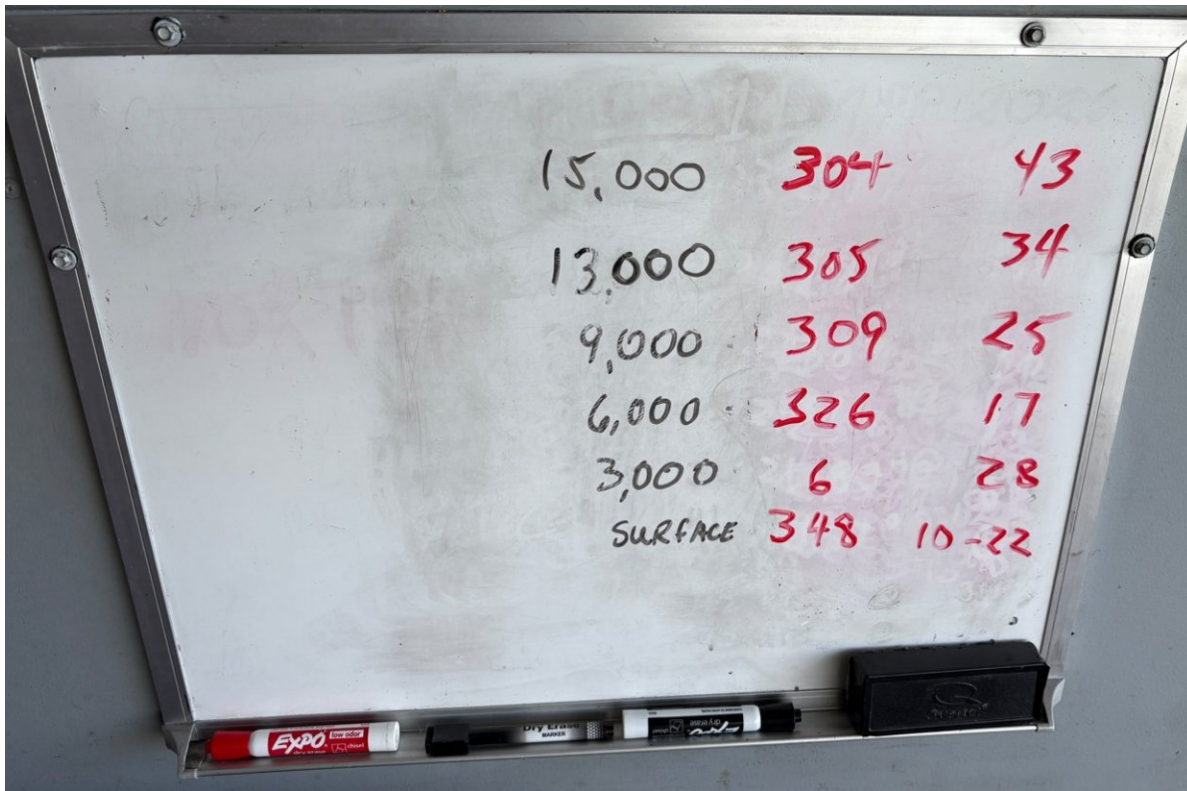
Figure 1. Image depicting the various wind speeds and directions on a whiteboard, for the different altitudes that the pilot researched and posted on the morning of the accident, located in the operator's building at BUM.

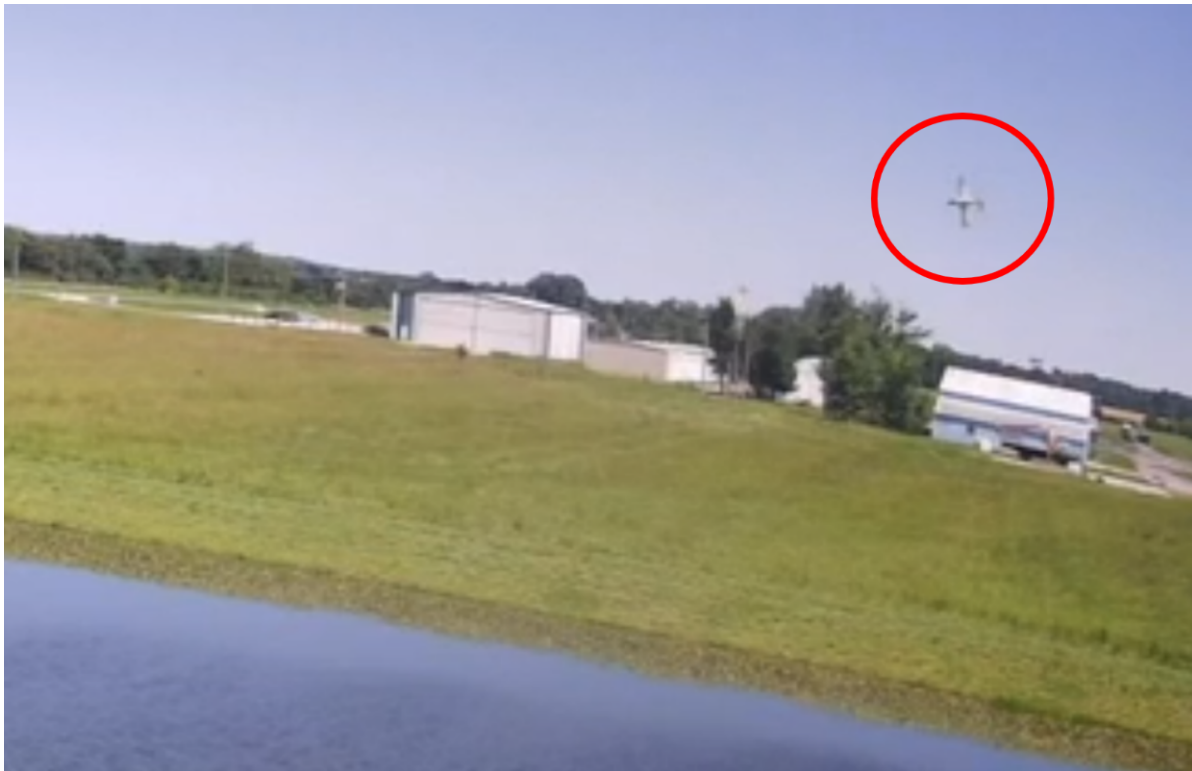
At 1125, the third flight of parachutists departed. A review of security video footage from a nearby aerial application operation hangar at BUM showed the airplane takeoff about mid-field from runway 36. During the initial climb, the airplane began a gradual turn to the left (to the west). A security video showed the airplane continuing to turn to the left, with both wings eventually becoming approximately perpendicular to the ground (see figure 2). The airplane then impacted a flat grass field in a nose down profile and a postimpact fire ensued. A search

Figure 2. Image depicting the security video footage screenshot showing the airplane in flight shortly before impacting terrain (security video footage courtesy of BCS Aerial). The airplane is annotated inside the red circle.

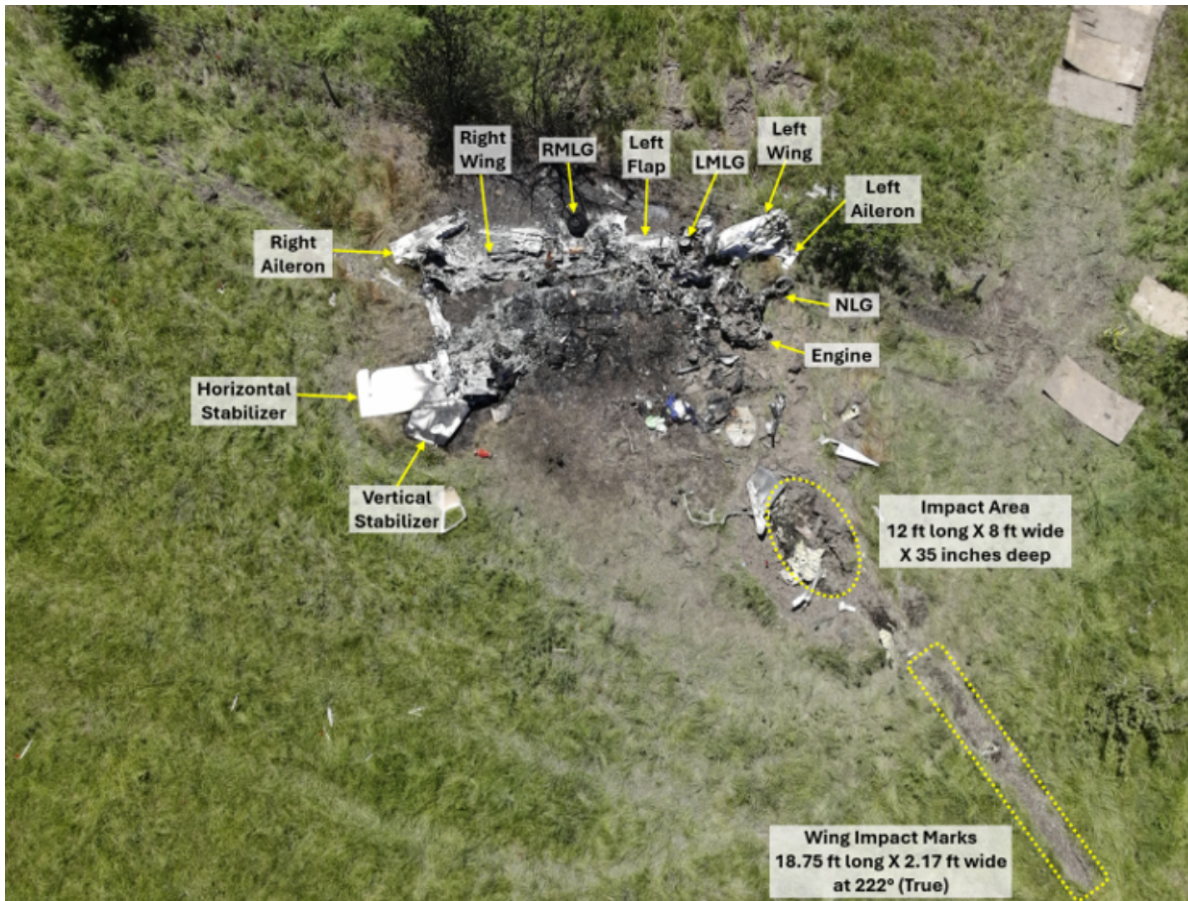
The accident site was located about 445 ft to the west of the southern end of the operator's LZ, near a north to south running barbed wire fence on BUM property. A postimpact fire consumed the wreckage.

Figure 3. Image depicting the wreckage at the accident site, with various airplane components labeled. Several airplane components were moved to facilitate the initial emergency response.

Postaccident examination of the airframe and engine revealed that all major structural components of the airframe were identified at the accident site; however, they had sustained significant thermal damage. Both the elevator and the rudder control systems sustained significant thermal damage. Measurements were obtained for the length of the flap gearbox jack screw extension, the length of the pitch trim actuator extension, and the length of the roll trim actuator extension to potentially determine the respective system positions at the time of the impact. The yaw trim system sustained significant thermal damage. The cockpit, the cabin, and the airframe fuel system all sustained significant thermal damage. The left and right direct aileron cables were removed and were transported to the NTSB Materials Laboratory for examination.
