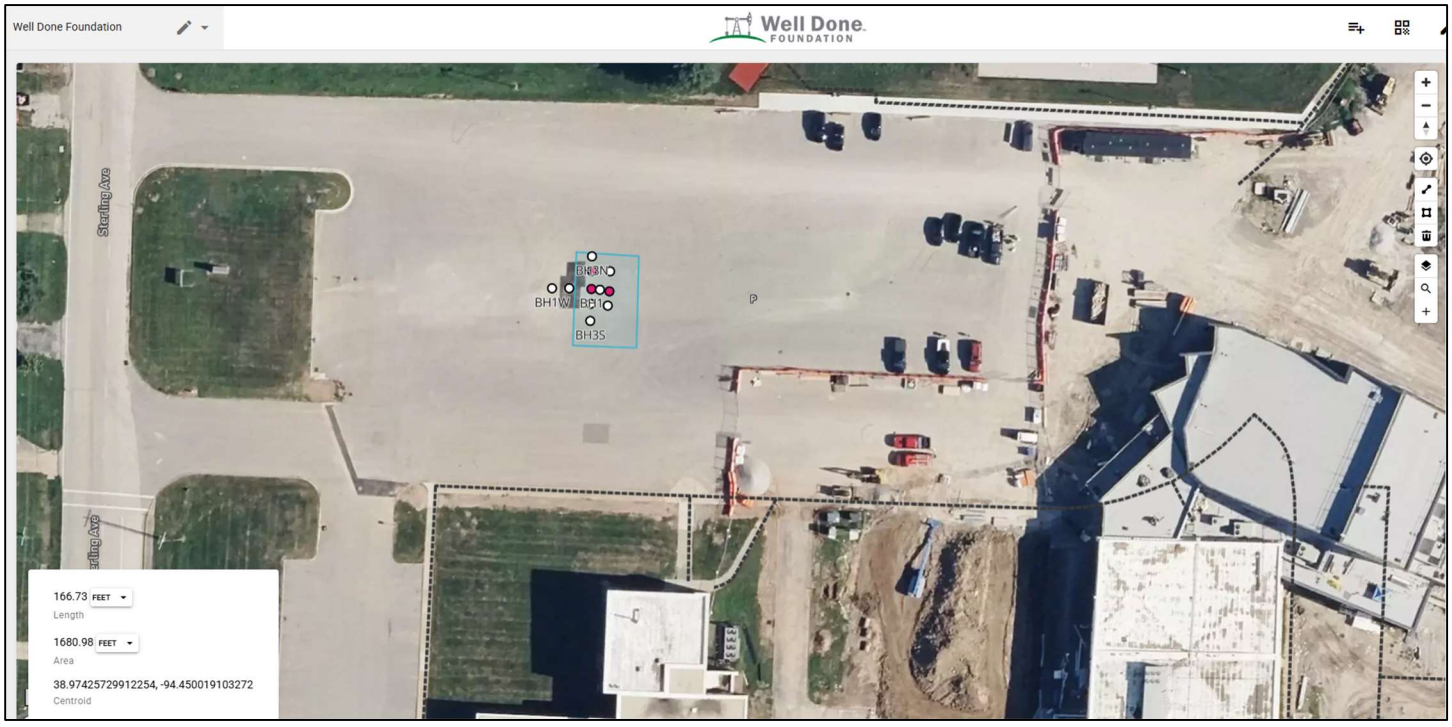
We believe that based on the laboratory analysis, coupled with the flow testing completed in the field on Sunday 8/17/2025, that we have outlined a reasonable approach for conducting exploratory excavation in the “hot spot” area highlighted below in blue to identify the point source of the methane gas making its way to the surface.

WDF will be on hand to directly supervise the exploratory excavation activities. If it is determined that the point source of the methane leaking is the result of a failed geothermal well, WDF will be prepared to take action to set a 5 ½” steel casing pipe to be cemented in place with a valve and flaring system installed to safely destroy methane emissions until the well can be shut in and a plan and permit can be submitted to the Missouri Department of Natural Resources and the well can be properly plugged and abandoned.

If the point source is determined to be the result of an abandoned gas well, WDF will be prepared to make up to the well and connect a flaring system to safely destroy the methane emissions until a well plugging and abandonment plan can be submitted to the Missouri Department of Natural Resources for approval.
